Thermal Rehabilitation of an Educational Building in the Context of the Adaptation of Buildings to the Effects of Climate Change. Case Study

Keywords: Energy efficiency audit, energy certificate, rehabilitation, thermal insulation

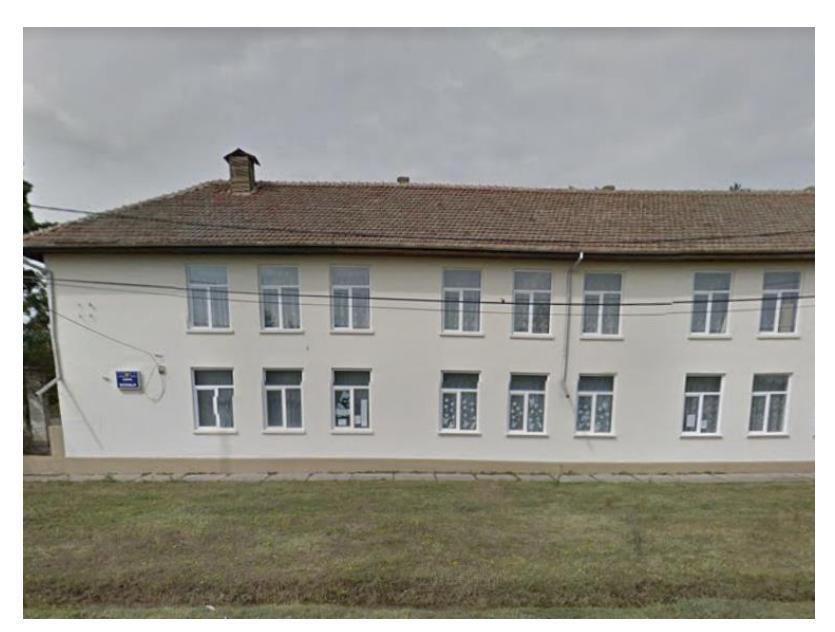
Fig. 2. Primary and Lower Secondary School of Giera

The object of this audit is the Primary and Lower Secondary School of Giera (Fig. 2). The building was built in the 60s, but various improvements have been performed over the years. The school has two floors, having 664.80 m² footprint, gross building area of 1150.10 m² and 943.10 m² net area [5].

The building as a whole has remained in good shape over the time (from the point of view of loadbearing structure). No cracks due to unequal settlement of earth or to seismic effects have been noticed until now [5].

After the visual control, the building has no structural damages to the main elements. The interior and exterior finishing works of the building floors and ceilings are damaged [6].

The building also has non-load-bearing damages and depreciation signs of the ceramic tiles (without negatively affecting the load-bearing structure of the roof truss) and of the rain water gutters. The ceiling of the entire building is made of wood revetment nailed under the wood logs covering the ground floor; the ceiling is plastered on a Rabitz plastering net. Earth has been introduced among the wood logs serving as thermal insulation [6].

Dark stains are visible inside the building due to growth of microorganisms on wet surfaces. Therefore, the exterior thermal insulation is insufficient mainly at corners and in between.

The thermal insulation of the ground floor ceiling is made of beaten clay, but it is damaged due to the age of the building and to the roof truss defects [6].

- Thermal insulation of the floor below the roof truss with stone wool of 20 cm and waterproofing renewal;

- Insulation of floor boarding with 6 cm extruded polystyrene and renewal of floors;

- Replacement of existing windows with double-glazed and wood joinery windows (R'=0.87 m²K/W);
