## Researches regarding the Behavior of CuAl10.5Ni5Fe4.8Mn1.5 at Erosion Generated by Vibratory Cavitation

**Abstract:** *The paper presents research results regarding the behavior at cavitation erosion of the CuAl10.5Ni5Fe4.8Mn1.5 bronze used in manufacturing ship propellers. For the experimental research it was used the Standard Vibratory Apparatus with piezoelectric crystals, of the Timisoara Polytechnic University Cavitation Laboratory. The analyze is realized by using the curves and parameters recommended in the ASTM G32-2010 Standard, the photographic images and the profiles of the surface subjected to cavitation. The resistance evaluation was obtained by comparisons with the behavior of the stainless steel OH12NDL for which we have numerous laboratory researches as well as detailed informations about the behavior in field running. The final conclusion is that the researched bronze has a very good cavitation erosion and can be used for manufacturing ship propellers.*

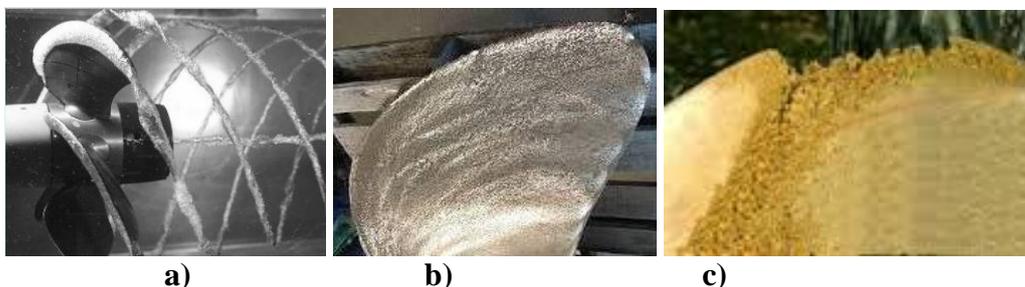
**Fig. 1.** Ship propellers running in cavitation and a blade eroded by cavitation [11]  
a) cavitation vortex at the propeller blade peak; b) blade with cavitation erosion;  
c) detail of the eroded zone

The cavitation effect upon ship propellers has been notified in the year 1848, when the first modern metallic passenger ship with mechanical propulsion constructed in Great Britain, was subjected to technical verification. The ship was designed by Isambard Kingdom Brunel and launched to the water in 1843 [12]. The negative effects such as important erosion and the reduction of the propulsion velocity were identified only in 1893 by Parsons [4, 7], after studies effected in a hydrodynamic tunnel. The aspect of the cavitation phenomenon and the effects upon the blades, both presented in Fig. 1, show that the most affected zones are blades tips [12].

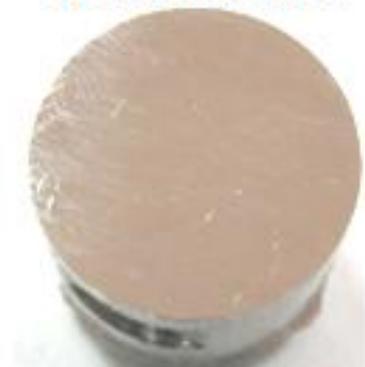
Surface exposed  
to cavitation

Fig. 2. The sample surface before cavitation exposure

Before beginning the tests the active surface of the samples were polished with abrasive paper and with the paste PROFILINE SONAX FS 05-04. The mean roughness of the active surface, before the beginning of tests (Fig. 2 present one of the three tested samples) was obtained with the portable roughness measuring device TR 110. The measuring was done in 6 points. The values for  $R_a$  are:

- for sample 1:  $R_a = 0.167 \mu\text{m}$ ,
- for sample 2:  $R_a = 0.171 \mu\text{m}$ ,
- for sample 3:  $R_a = 0.179 \mu\text{m}$

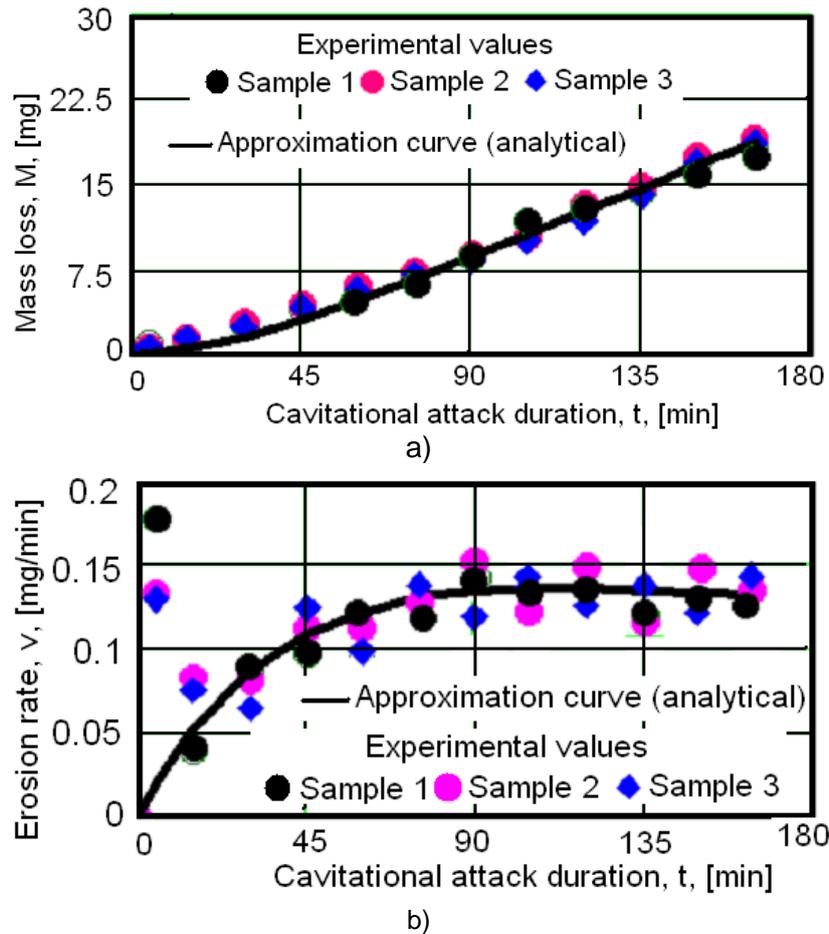
**Fig. 3.** Specific curves of behavior evolution and cavitation resistance  
 a) mass loss against the exposure to cavitation attack  
 b) erosion rate against exposure to cavitation attack

The approximation curves were used for analyzing the erosion evolution during the exposure time, taking into account both the shape and the scatter of experimental points. In order to evaluate the mass losses, were used the mean mass losses obtained on the three samples, for each intermediary testing period, the cumulative mass loss as well as the loss velocity. In order to assess the cavitation erosion resistance, the obtained curves were compared with those obtained for the OH12NDL stainless steel, material with good behavior both in laboratory tests and in the field in the operation of hydraulic turbines. Supplementary, there were made comparisons between the stable velocities for final erosion exposure times. In Fig. 3 are presented the experimental obtained values together with the cavitation erosion characteristic curves.

The dispersion of the experimental points with regard to the mediation curves show that cavitation erosion is a statistic event. Thousands of tiny and patchy bubbles impacts very tiny sample areas, each with his one resistance. That is why three samples obtained from the same rod presents cavitation erosion resistance with small differences. The evolution of curve  $M(t)$  in Fig. 3a show that, beginning approximately with the minute 45, its shape is almost linear, it means that from this moment the behavior of the bronze remain approximately the same till the final exposure time. The curve  $v(t)$  gives more exactly values for the beginning of the stabilization curve, namely the minute 90 but the difference between the maximum velocity and the final value is very small (0.126 mg/min).

The differences between the experimental values and the approximation curves, till the minute 15 (see Fig. 3b) are given by the metallic dust and the sharp roughness expelled in this period. Normal this beginning period is not taken into account in the material behavior analyze, because it depends in great measure on the sample polishing and cleaning before the beginning of tests [1], [7].

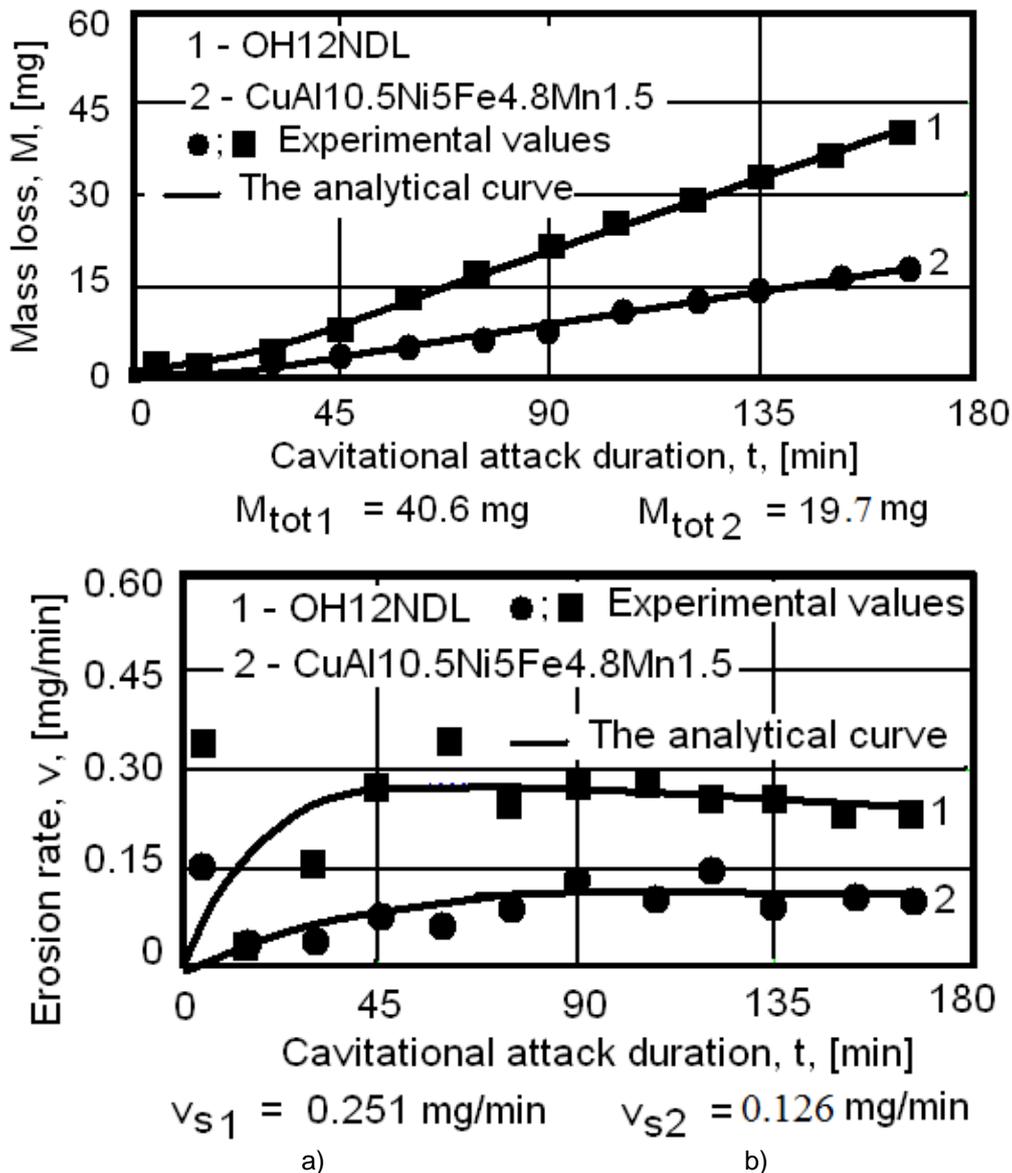
Fig. 4. Comparison with OH12NDL etalon steel:  
a) mass loss comparison; b) erosion rate comparison

To put into evidence the cavitation erosion behavior, as well as the resistance to the mechanical fatigue stresses generated by the impacts of the surface with the microjets and the shock waves generated by the implosion of the cavitation bubbles, in Fig. 4 there are made comparisons between the obtained experimental curves and values and those for the martensitic stainless steel OH12NDL for which we have both laboratory experimental results and field results in hydraulic turbines. In the same time there were made discussions regarding the comparisons between specific parameters ( $M_{tot}$  and  $v_s$ ).

Taking into account the values of both parameters the resistance of the researched bronze is about two times greater than the resistance of the martensitic stainless steel OH12NDL. In conclusion the bronze CuAl10.5Ni5Fe4.8Mn1.5 has excellent behavior to cavitation erosion.

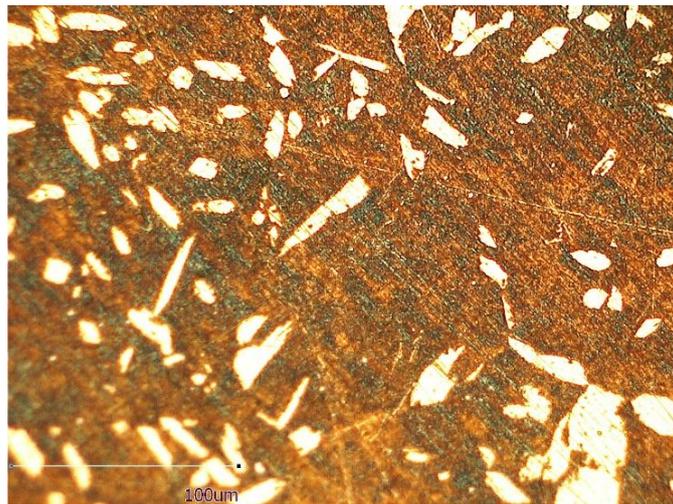
**Fig. 5.** Microstructure of the bronze CuAl10.5Ni5Fe4.8Mn1.5 (1750 x)

The images presented in Fig. 5 (before the cavitation exposure, on separate specimens designed only for this purpose) and in Fig 6 (specimens subjected to the maximum exposure time) show that the microstructure of the material is constituted in principal from a solid solution  $\alpha$  and a small proportion of the eutectoid  $\alpha + \gamma'$ .

The images of figures 5...7 reveal the peculiarities of the eroded surface degraded by cracks at the grain boundaries but also by realizing caverns and pitting as the result of the expelled grains. Because the solid solution  $\alpha$  gives a good plasticity and the eutectoid enhances the mechanical characteristics, the initiation of the cavitation erosion take place at the interface of these two structural constituents and only afterwards continues with expelling of the whole grain. This behavior results from the images presented in Fig. 6. Supplementary, the electronic scanning microscopy put into evidence the formation of annealing mackles and the priority expelling of the solid solution grains.

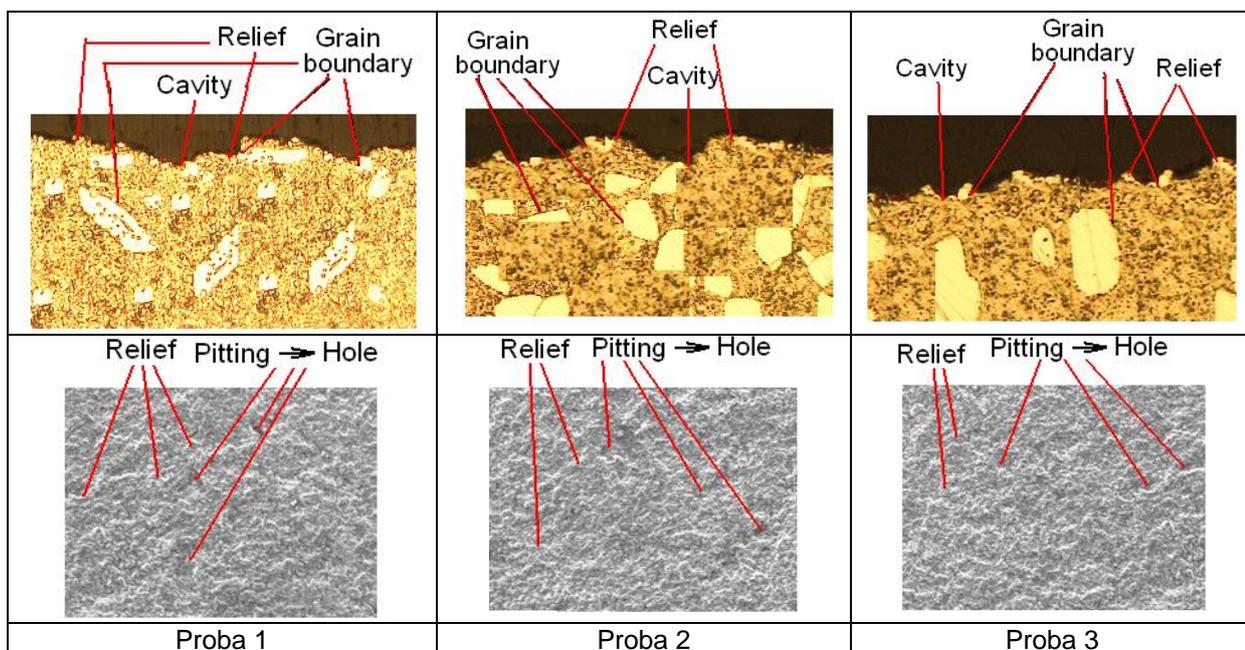
**Fig. 6.** Images of structure degradation (pitting, hole, deformations) Final exposure time, 165 minutes (1750x)

In comparison with the images in Fig. 6 it can be seen a very good concordance between the profiles and the erosion mechanism. Taking into account the bronze density, computed upon the chemical composition (7.45 grams/mm<sup>3</sup>) it results that the maxim penetration depth computed with the relation:

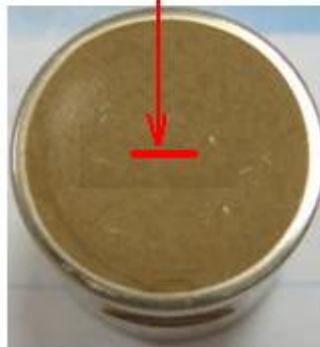
Recording area with Mitutoyo roughness apparatus

Fig. 7. Recording zone of cavitated area roughness, with the Mitutoyo apparatus

The images in Fig. 8 presents the profiles of the eroded surface, obtained in the central zone, in conformity with Fig 7, on a 4 mm length, using the roughness device Mitutoyo.

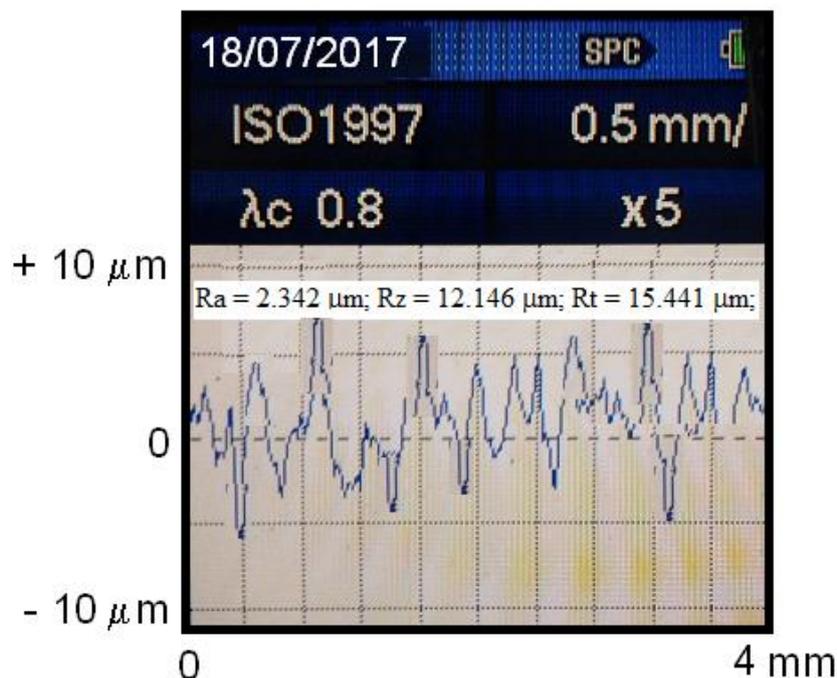
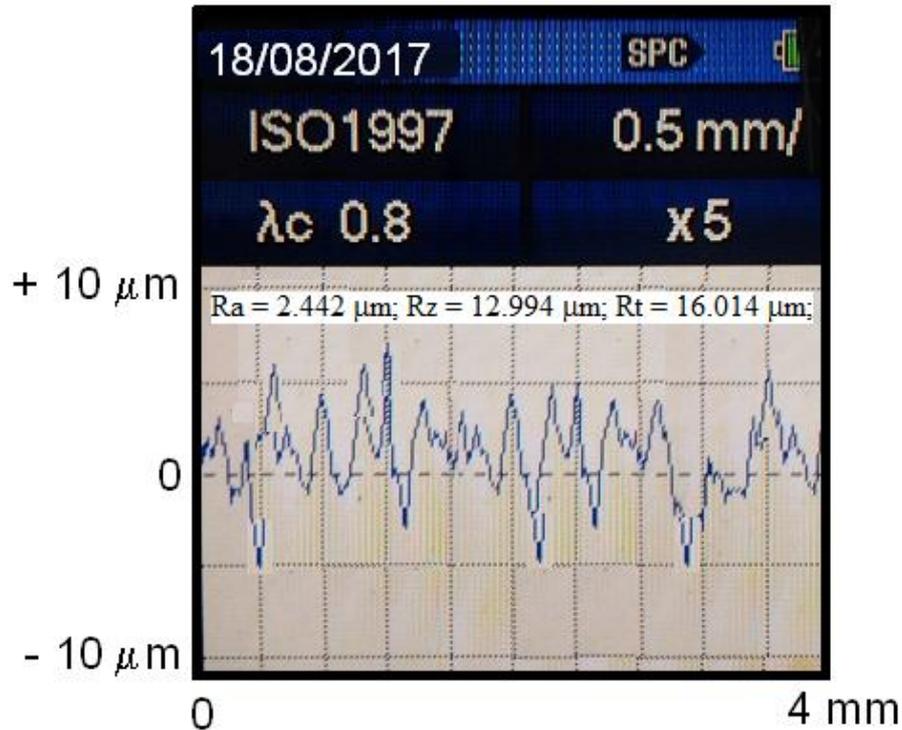
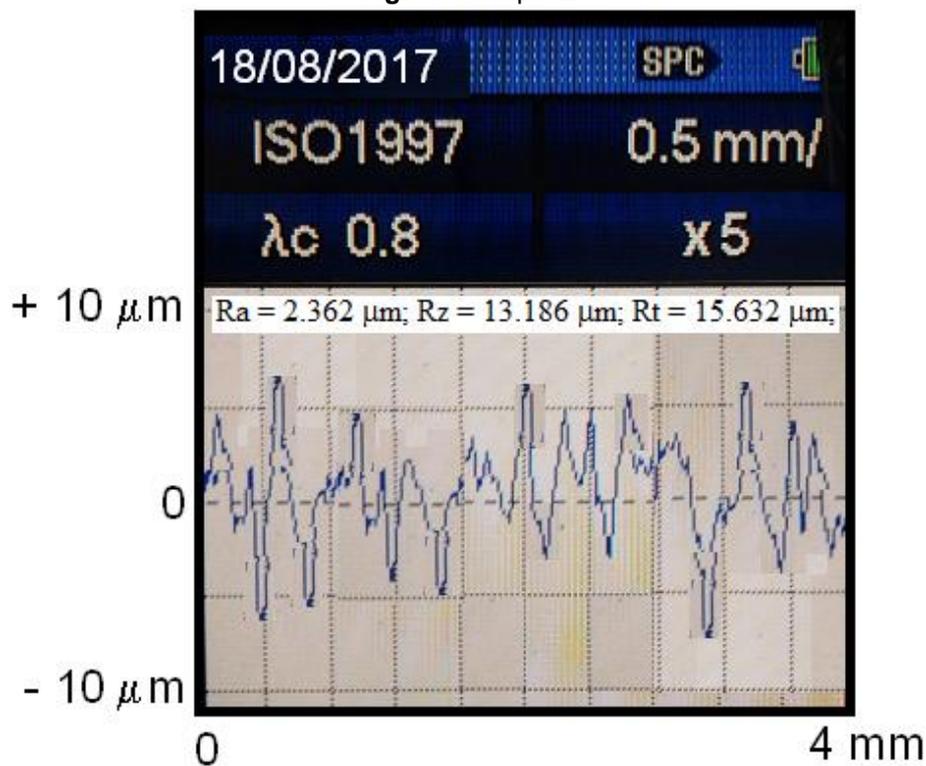
Fig. 8. Profile of the eroded surface, recorded in the center of the cavitated area

The roughness profile, obtained with a Mitutoyo device, confirm the uniform degradation of the cavitation exposed surface, the behavior being specific for materials with very good cavitation erosion behavior, as well as with fine structures, great homogeneity which give uniform mechanical properties.
