Resistance and Behavior to Cavitation Erosion of Semi-Finished Aluminum Alloy 5083

Abstract: Among the applications of aluminum-based alloys is that in the field of hydraulic installations and equipment. Some components of their structure, such as the rotors of the cooling pumps of motor vehicles, or the blades of propellers from the engines of fishing boats, or pleasure boats, and even the radiators of motor vehicles are subject to corrosion by the cavity created during operation. Among the aluminum alloys used in the manufacture of such components is the alloy 5083. These parts can be made by casting (rotors / pump housings and steam propeller) or laminated semi-finished products, such as blades for rotors / propellers with adjustable vanes. Cavitation operation inevitably leads to damage by erosion caused by cyclic stresses of micro-jets and shock waves generated by the implosion of cavitation bubbles. As a result, the paper presents the results regarding the degradation by vibration cavitation of alloy 5083, in the form of cast and rolled semi-finished product. The curves and parameters specific to the resistance of the alloy to cavity erosion, as well as the images of eroded

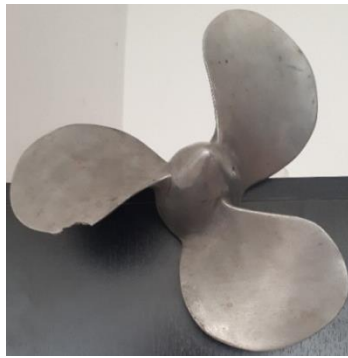
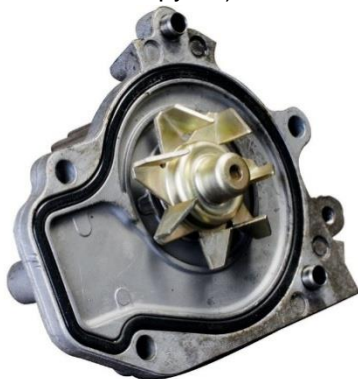
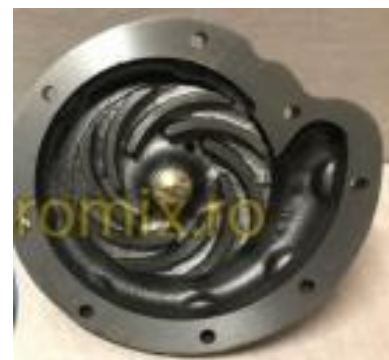
Fig. 1. Various propellers and motor vehicle cooling pumps, made of aluminum-based alloys

a) Boat propeller that sailed on the Danube (purchased from the Drobeta Turnu-Severin Shipyard)

b) Boat engine propellers

c) Car cooling pump

d) Tractor cooling pump

Aluminum-based alloys, known as duralumin, have a very high industrial application, due to their low specific mass (less than 3 g / cm³) and high mechanical properties. The best known are from the food, automotive, aircraft and naval industries [1, 2]. A series of components more or less mechanically, hydrodynamically or chemically stressed made from these alloys are made. For those required hydrodynamically, specialists are looking for solutions to increase the surface resistance to cyclic stresses of micro-jets and shock waves, which cause degradation by erosion. Such parts are the rotors of household well pumps, the rotors of water pumps for cooling car engines (fig.1 c and d), the stern of boats (where the cavitation vortex is manifested), the propellers of boat engines (fig.1 b) and of the pleasure boats (fig.1.a), respectively the attack board of the

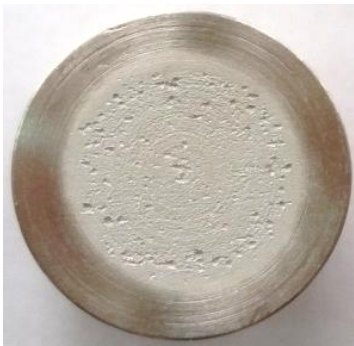
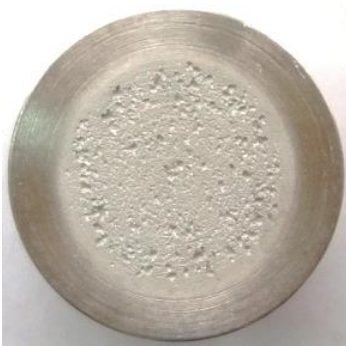
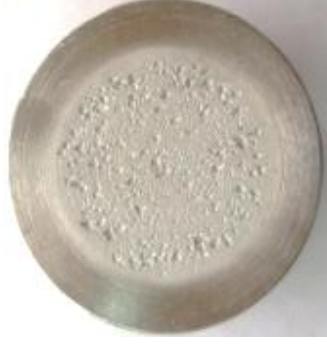
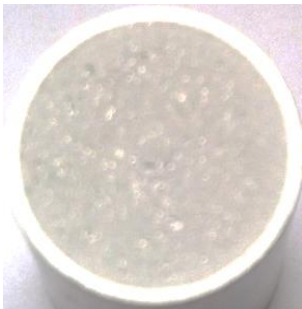
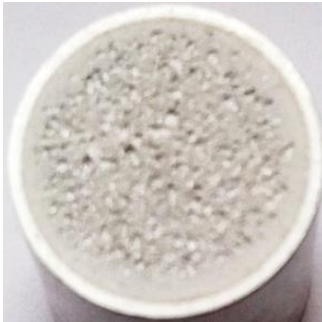
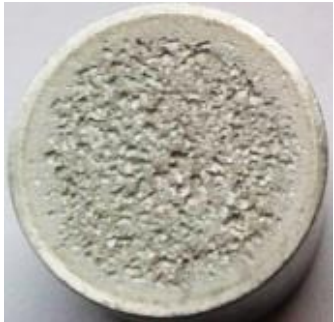
Table 3: Macro-photographed images at significant times

Table 3 gives images of eroded surfaces, at three significant times, for one of the three samples tested in each material. The images, depending on the size of the caverns and the area in which they extend, highlight the differences in behavior and resistance to the cyclical stresses of local fatigue produced by micro-jets and shock waves.

The larger shape and dimensions of the caverns produced in the layer of laminate semi-finished product (5083 L) are observed. This is the effect of lower values of KCV resilience (property that strongly influences the absorbed energy to break the bonds between the crystalline grains), but also of the mechanical breaking strength R_m and the yield strength $R_{p0.2}$.

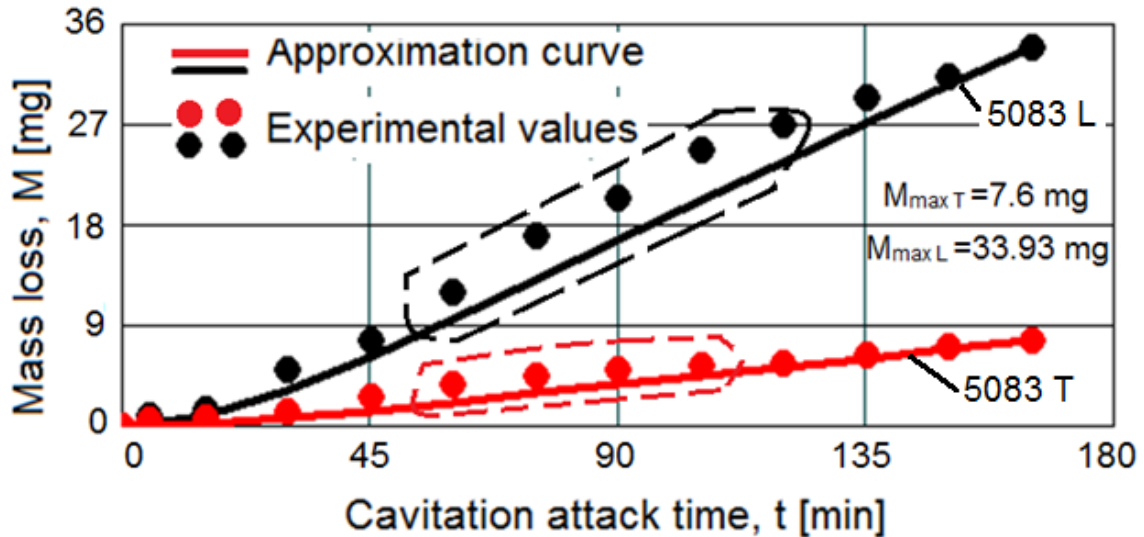
In fig. 3 and 4 show the specific cavitation diagrams, constructed based on the mediation of the mass losses recorded at the end of each intermediate period "i" (one of 5 and 10 minutes and 10 of 15 minutes each [9]), on the three samples tested, using the relationships:

Fig. 3. Variation of mass losses with the duration of the cavitation attack

The dispersion of the experimental values, regardless of the diagram, $M(t)$ or $v(t)$, compared to the mediation curves, shows that the two materials have a similar behavior, a fact proven by the interval of 60-120 minutes. This resemblance is natural, due to the fact that they are the same material (see chemical composition in Table 2). The differences between the values of the parameters, M_{max} (total mass lost by erosion in the 165 minutes of cavitation attack), v_{max} and v_s (maximum values and towards which the mediation-called and stabilization or final curve asymptotically tends - defined by the mediation curve $v(t)$), which express the cavitation strength are determined, in this situation, by the values of the mechanical properties (R_m , $R_{p0.2}$ and KCV),

as mentioned in paragraph 3.2.1. Thus, according to the value of M_{\max} , erosion rate, v_s , or cavitation resistance R_{cav} ($R_{\text{cav}} = 1 / v_s$) the 5083 T alloy has a higher resistance than the 5083 L alloy 4.4 ... 4.6 times.
